h/p/cosmos sports & medical gmbh

December 10, 2015

Field safety notice to ripcords for treadmills built in 2014/2015

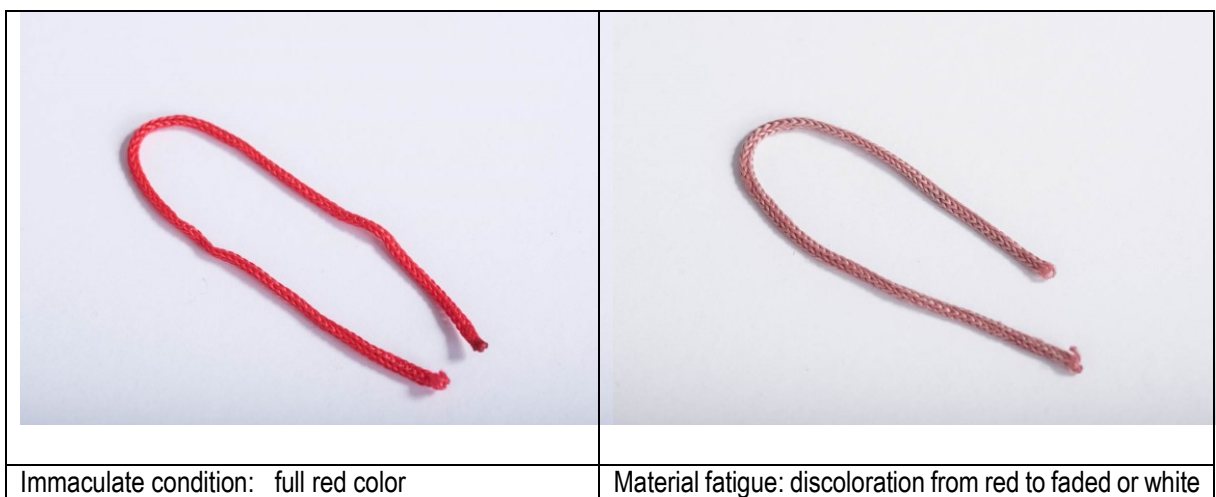
1. Please make a visually and functional control of the ripcord including clip and magnetic switch.
2. The cord must have a full red color and must not show any cracks or damages.
3. Apply a tensile load of about 1 kg (10 N) at the clip. The cord must pull the magnet off the magnetic switch. The treadmill has to stop.
4. If the color fades this indicates premature aging due to external influences. The same applies for any cracks or other obvious damages of tissue.

In case of any detected or assumed damage or malfunction, please inform us immediately via email to safety@h-p-cosmos.com or call us on +49 86 69 86 42 0.

We will send you the appropriate spare parts promptly and without charge.
